# Impact Management Plan

## *Melaleuca irbyana*

432-520 Greenbank Road, Greenbank  
Prepared for Mirvac Queensland Pty Ltd  
3 July 2018

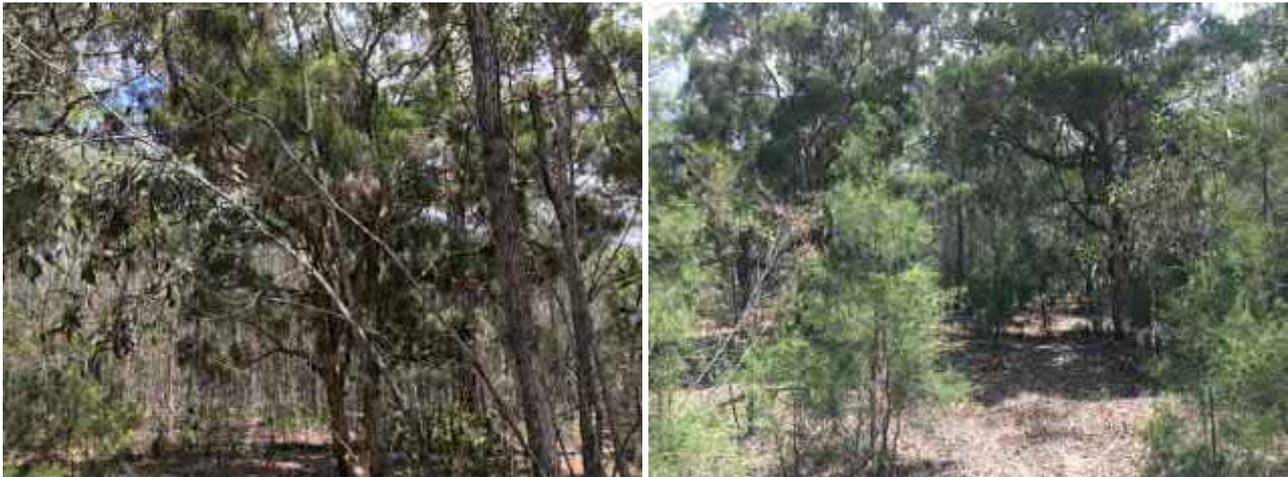
**Photo Plate 1: Location 1**

Location 1 is situated in the northern aspect of the site, adjacent to the power easement. This patch is located within mapped composite 'Of Concern' Regional Ecosystem RE12.9-10.2/12.9-10.7 as confirmed via PMAV 2016/002969 certified on the 11<sup>th</sup> of May 2017. Refer to Plan 1 for *Melaleuca irbyana* on site locations and Table 3 for a description of the Regional Ecosystems). This patch of *Melaleuca irbyana* (Swamp Tea-tree) consisted of three (3) established specimens and one-hundred (100) juveniles. This patch of *Melaleuca irbyana* was surrounded by vegetation dominated by *Acacia spp.*, *Allocasuarina littoralis* (Black She-oak) and *Alphitonia excelsa* (Soap Tree) regrowth with *Corymbia citriodora* (Spotted Gum) dominated canopy.

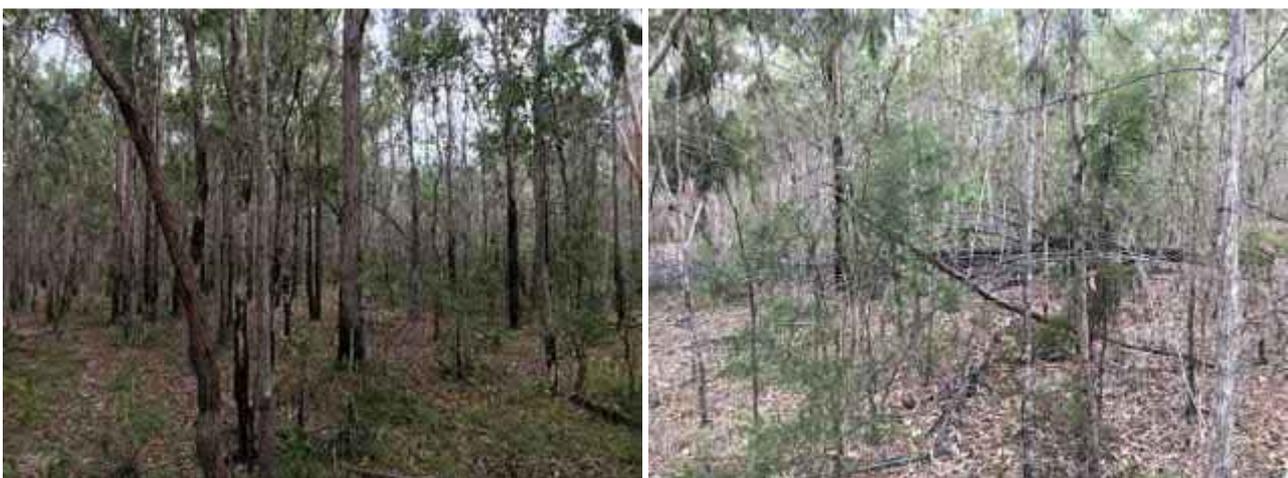
**Photo Plate 2: Location 2**

Location 2 is situated towards the south-western property boundary, adjacent to Greenbank Road. This patch is located within mapped non-remnant vegetation as confirmed via PMAV 2016/002969 certified on the 11<sup>th</sup> of May 2017. This *Melaleuca irbyana* (Swamp Tea-tree) patch consisted of three (3) established specimens and twenty (20) juveniles. This patch of *Melaleuca irbyana* was found within a regrowth vegetation community, with surrounding vegetation dominated by *Allocasuarina littoralis* (Black She-oak) and *Acacia spp.* regrowth.

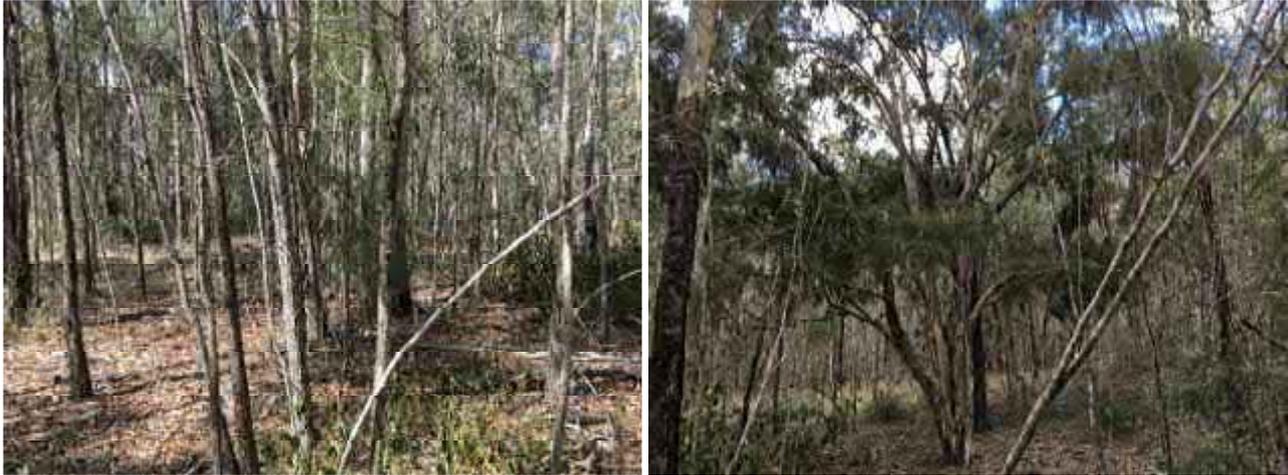
**Photo Plate 3: Location 3**

Location 3 is situated towards the south-western property boundary, adjacent to Greenbank Road and approximately 380 m west of Location 2. This patch is located within mapped non-remnant vegetation as confirmed via PMAV 2016/002969 certified on the 11<sup>th</sup> of May 2017. This patch of *Melaleuca irbyana* (Swamp Tea-tree) consisted of four (4) established specimens and ten (10) juveniles. The patch of *Melaleuca irbyana* was found within a regrowth vegetation community, with surrounding vegetation dominated by *Acacia spp.*, *Allocasuarina littoralis* (Black She-oak) and *Alphitonia excelsa* (Soap Tree) regrowth.

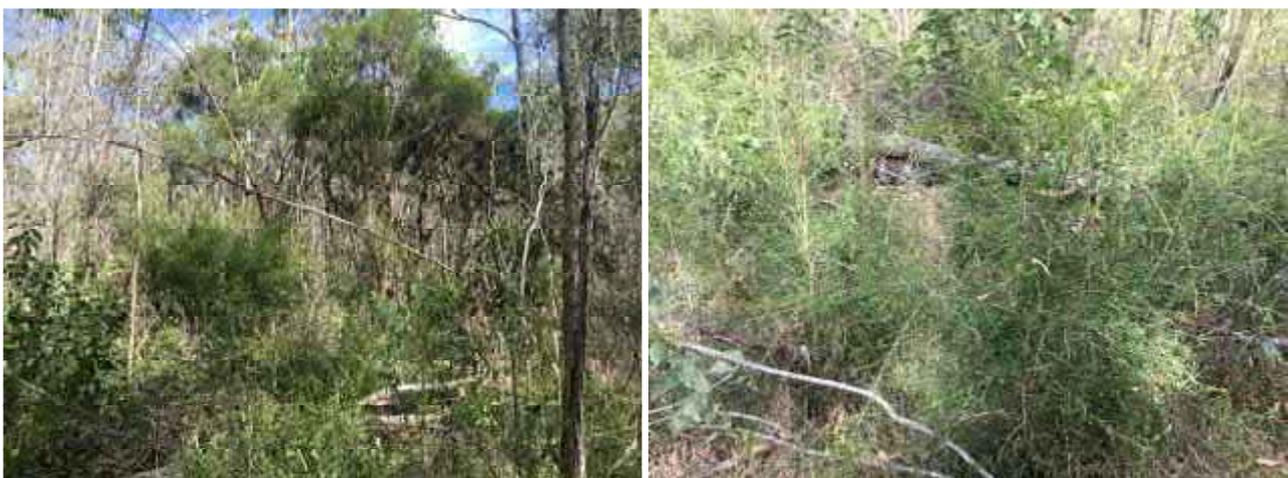
**Photo Plate 4: Location 4**

Location 4 is situated towards the southern property boundary, approximately 800 m east of Location 2. This patch is located within mapped composite 'Of Concern' Regional Ecosystem RE12.9-10.2/12.9-10.7 as confirmed via PMAV 2016/002969 certified on the 11<sup>th</sup> of May 2017. These Regional Ecosystems are described in Table 3 below. This patch consists of five (5) established specimens and one hundred and ninety-eight (198) juveniles. This patch of *Melaleuca irbyana* was surrounded by vegetation dominated by *Acacia spp.*, *Allocasuarina littoralis* (Black She-oak) and *Alphitonia excelsa* (Soap Tree) regrowth with *Corymbia citriodora* (Spotted Gum) dominated canopy.

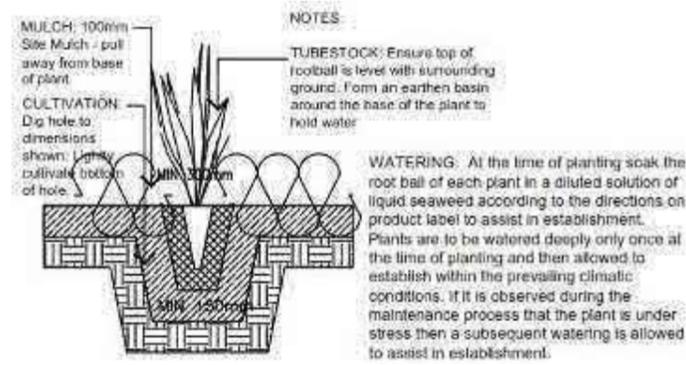
Each individual planting location should be spot cultivated to at least 2 times the depth and twice the width of the plant stock size. Refer detail for more specifications:

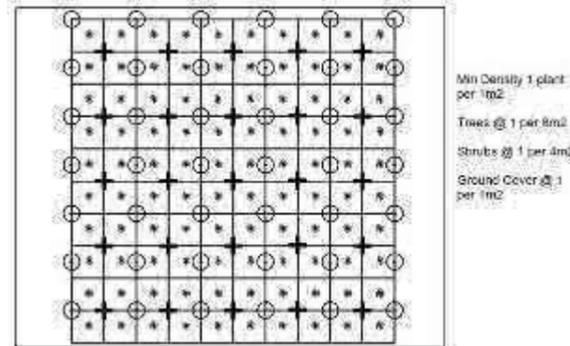
Planting locations shall be generally set out in accordance with a typical random grid pattern as shown on this drawing sheet below with the *Melaleuca Irbyana* to be planted at 1 per 8m<sup>2</sup>.

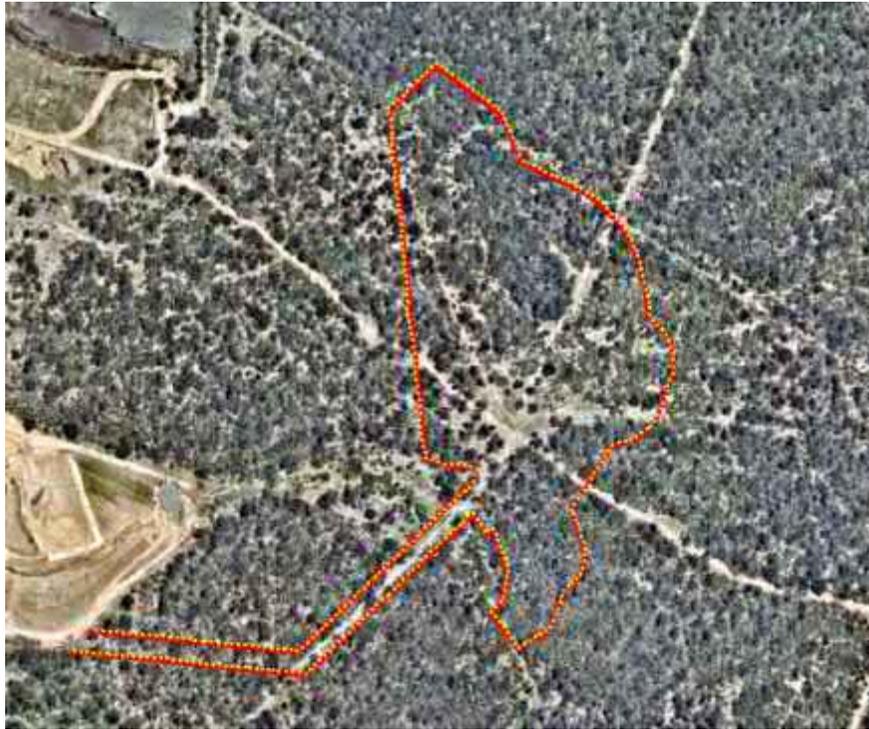
Figure 1 – Extent of Phase 1 Clearing

The site specific including proposed clearing zone and large farm dam is located to the east of Teviot Road within the Greenbank locality with the specific project being tree clearance and dam de-watering for residential estate construction. The site is prior rural land-use area of minor slope containing wattle/Eucalypt re-growth and larger early mature to mature eucalypts, located adjacent to recent residential development with assessment of fauna value detailed below.

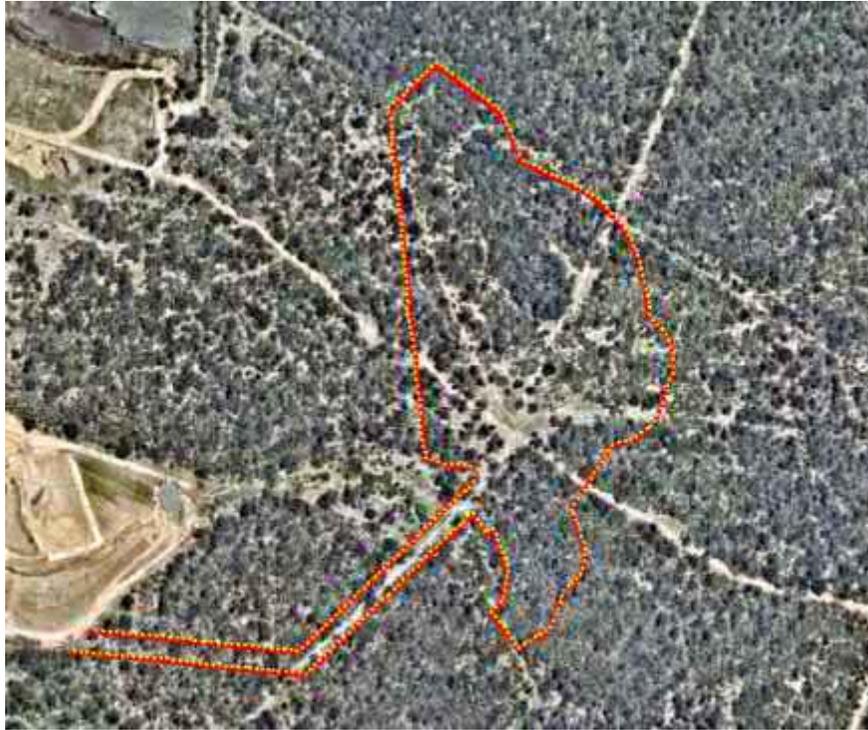
Figure 1 – Extent of Phase 1 Clearing

The site specific including proposed clearing zone and large farm dam is located to the east of Teviot Road within the Greenbank locality with the specific project being tree clearance and dam de-watering for residential estate construction. The site is prior rural land-use area of minor slope containing wattle/Eucalypt re-growth and larger early mature to mature eucalypts, located adjacent to recent residential development with assessment of fauna value detailed below.

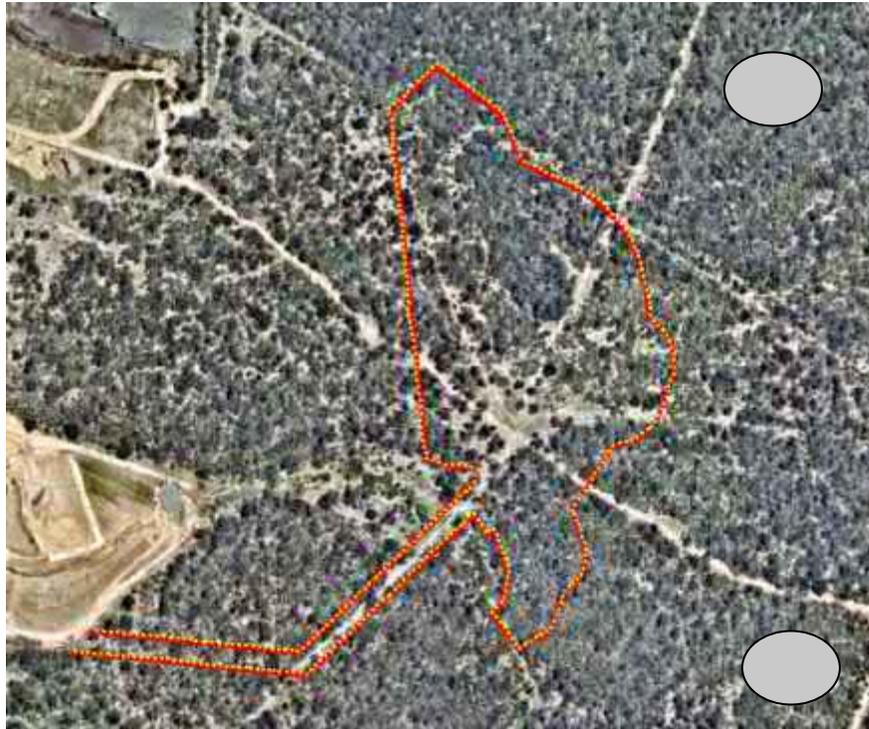
• Figure 2 – Location of captured fauna

normal activity times for the animal concerned. All fauna captured will be released in adjacent bushland, containing suitable habitat, outside the clearing zone and within 500 m of the proposed clearing zone.
