Fauna Management Plan

Everleigh - Proposed School Site
432-520 Greenbank Road, Greenbank Qld 4124

Prepared for Mirvac Queensland Pty Ltd
2 October 2019

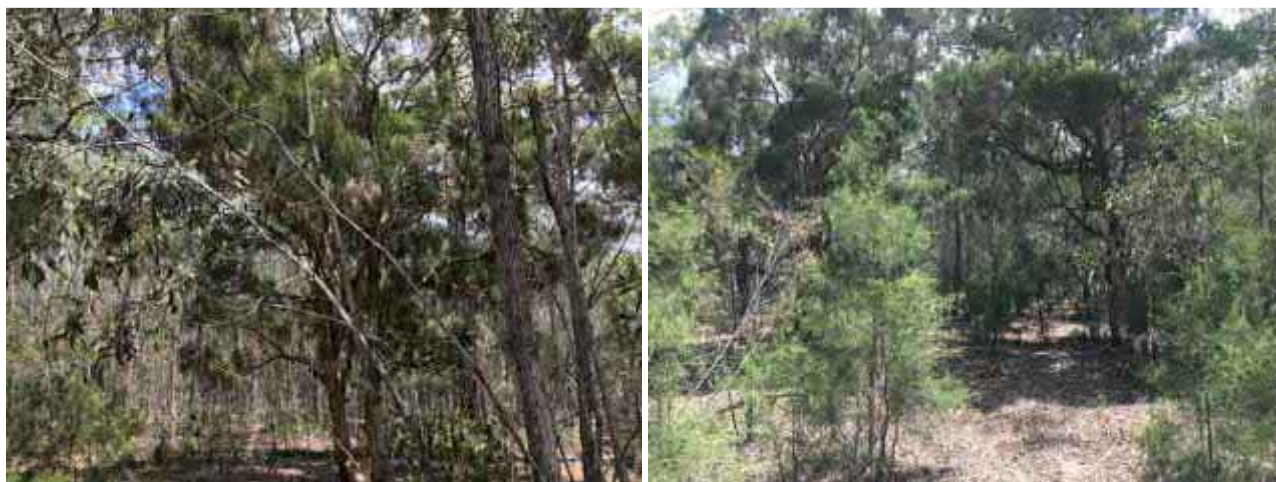
Photo Plate 1: Location 1

Location 1 is situated in the northern aspect of the site, adjacent to the power easement. This patch is located within mapped composite 'Of Concern' Regional Ecosystem RE12.9-10.2/12.9-10.7 as confirmed via PMAV 2016/002969 certified on the 11th of May 2017. Refer to Plan 1 for *Melaleuca irbyana* on site locations and Table 3 for a description of the Regional Ecosystems). This patch of *Melaleuca irbyana* (Swamp Tea-tree) consisted of three (3) established specimens and one-hundred (100) juveniles. This patch of *Melaleuca irbyana* was surrounded by vegetation dominated by *Acacia spp.*, *Allocasuarina littoralis* (Black She-oak) and *Alphitonia excelsa* (Soap Tree) regrowth with *Corymbia citriodora* (Spotted Gum) dominated canopy.

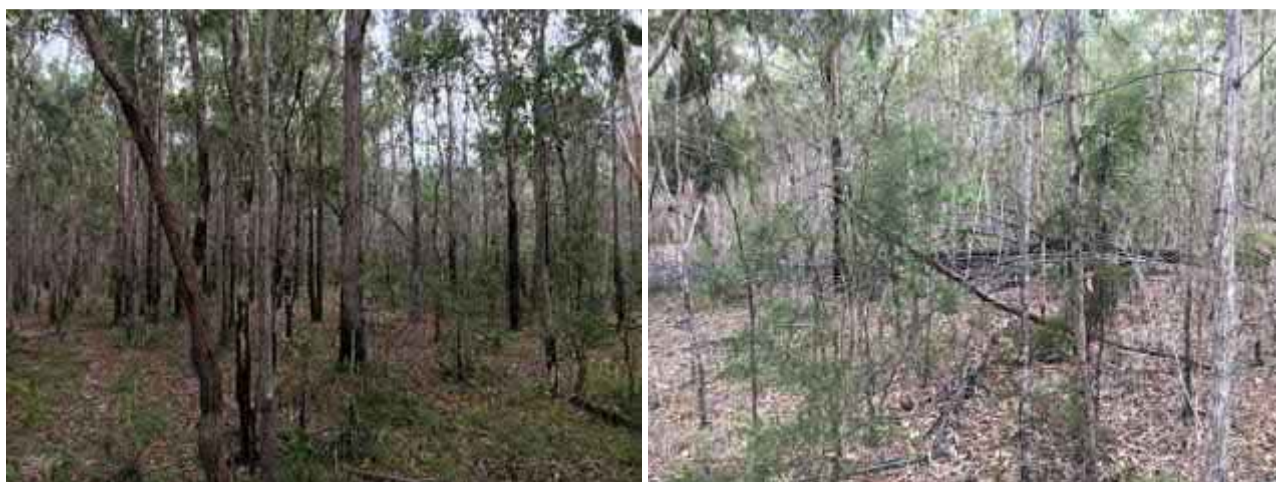
Photo Plate 2: Location 2

Location 2 is situated towards the south-western property boundary, adjacent to Greenbank Road. This patch is located within mapped non-remnant vegetation as confirmed via PMAV 2016/002969 certified on the 11th of May 2017. This *Melaleuca irbyana* (Swamp Tea-tree) patch consisted of three (3) established specimens and twenty (20) juveniles. This patch of *Melaleuca irbyana* was found within a regrowth vegetation community, with surrounding vegetation dominated by *Allocasuarina littoralis* (Black She-oak) and *Acacia spp.* regrowth.

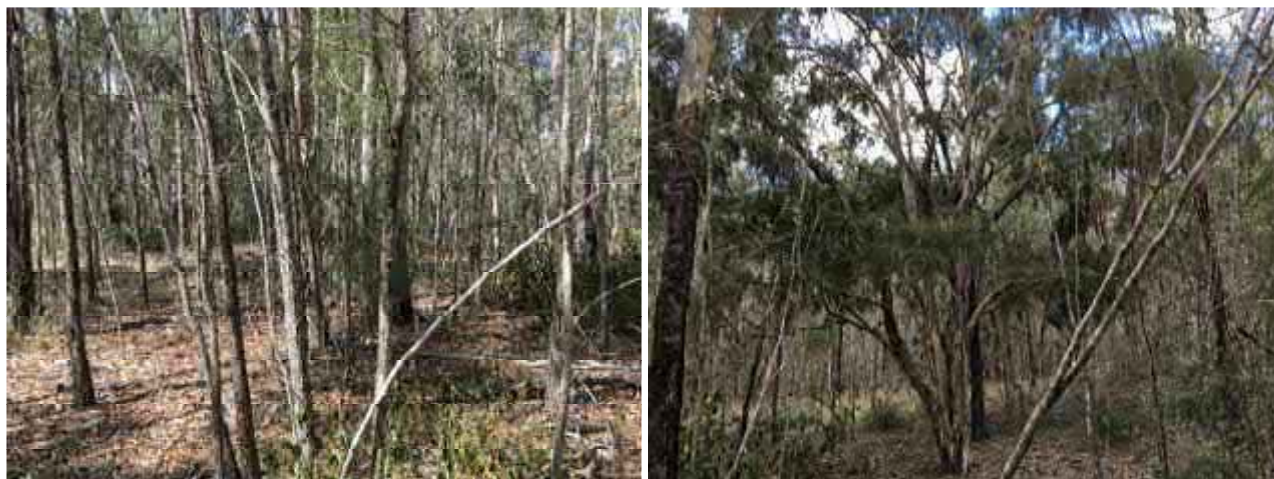
Photo Plate 3: Location 3

Location 3 is situated towards the south-western property boundary, adjacent to Greenbank Road and approximately 380 m west of Location 2. This patch is located within mapped non-remnant vegetation as confirmed via PMAV 2016/002969 certified on the 11th of May 2017. This patch of *Melaleuca irbyana* (Swamp Tea-tree) consisted of four (4) established specimens and ten (10) juveniles. The patch of *Melaleuca irbyana* was found within a regrowth vegetation community, with surrounding vegetation dominated by *Acacia spp.*, *Allocasuarina littoralis* (Black She-oak) and *Alphitonia excelsa* (Soap Tree) regrowth.

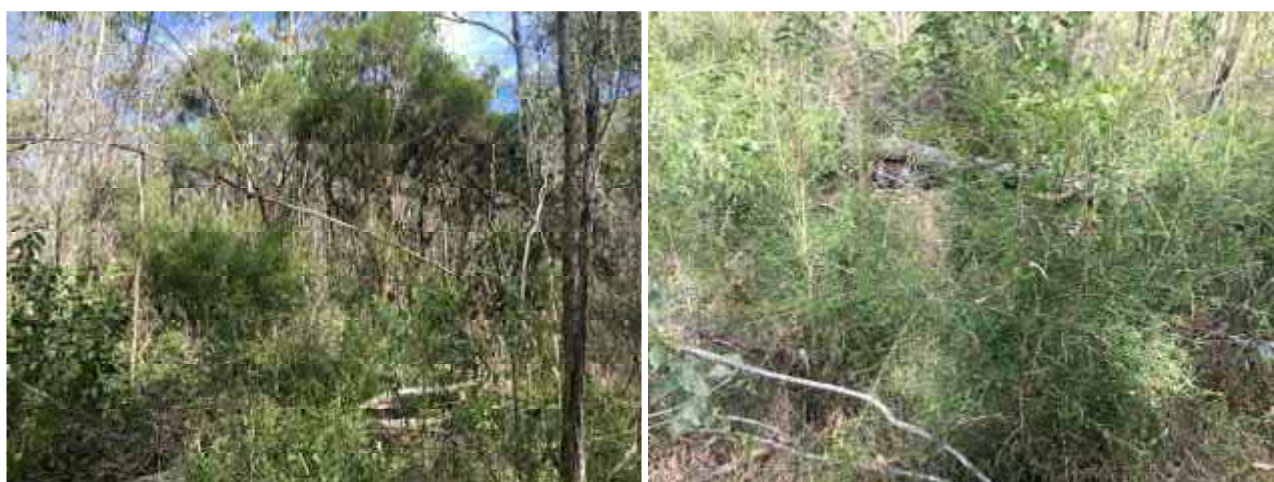
Photo Plate 4: Location 4

Location 4 is situated towards the southern property boundary, approximately 800 m east of Location 2. This patch is located within mapped composite 'Of Concern' Regional Ecosystem RE12.9-10.2/12.9-10.7 as confirmed via PMAV 2016/002969 certified on the 11th of May 2017. These Regional Ecosystems are described in Table 3 below. This patch consists of five (5) established specimens and one hundred and ninety-eight (198) juveniles. This patch of *Melaleuca irbyana* was surrounded by vegetation dominated by *Acacia spp.*, *Allocasuarina littoralis* (Black She-oak) and *Alphitonia excelsa* (Soap Tree) regrowth with *Corymbia citriodora* (Spotted Gum) dominated canopy.

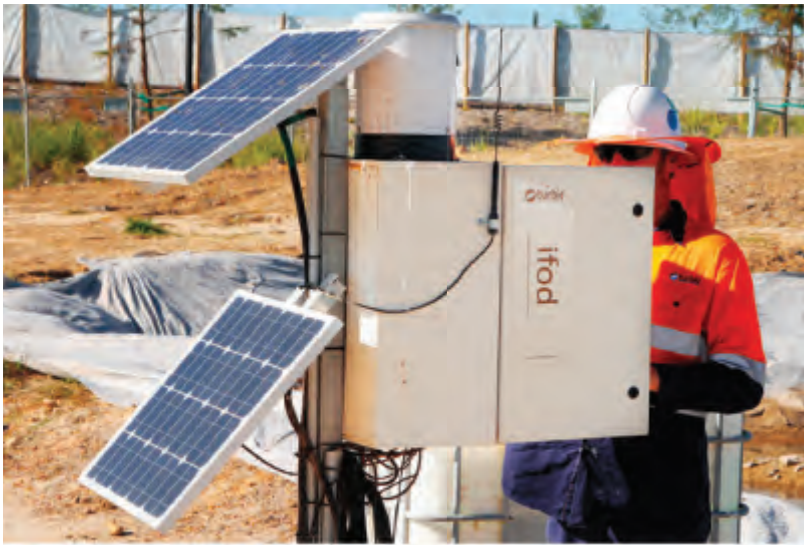
iFOD RAIN DOSING UNIT (CUSTOM BUILT)
