Everleigh

Environmental Pre-Start Checklist

Erosion and Sediment Control Plan

CLIENT: MIRVAC GROUP
 PROJECT: EVERLEIGH SPORTS & REC PARK LOTS 804-805 - DRAWING SET 1
 LOCATION: TEVIOT ROAD, GREENBANK
 SHEET TITLE: EROSION AND SEDIMENT CONTROL LAYOUT-CLEAR AND GRUB PHASE 1 OF 2

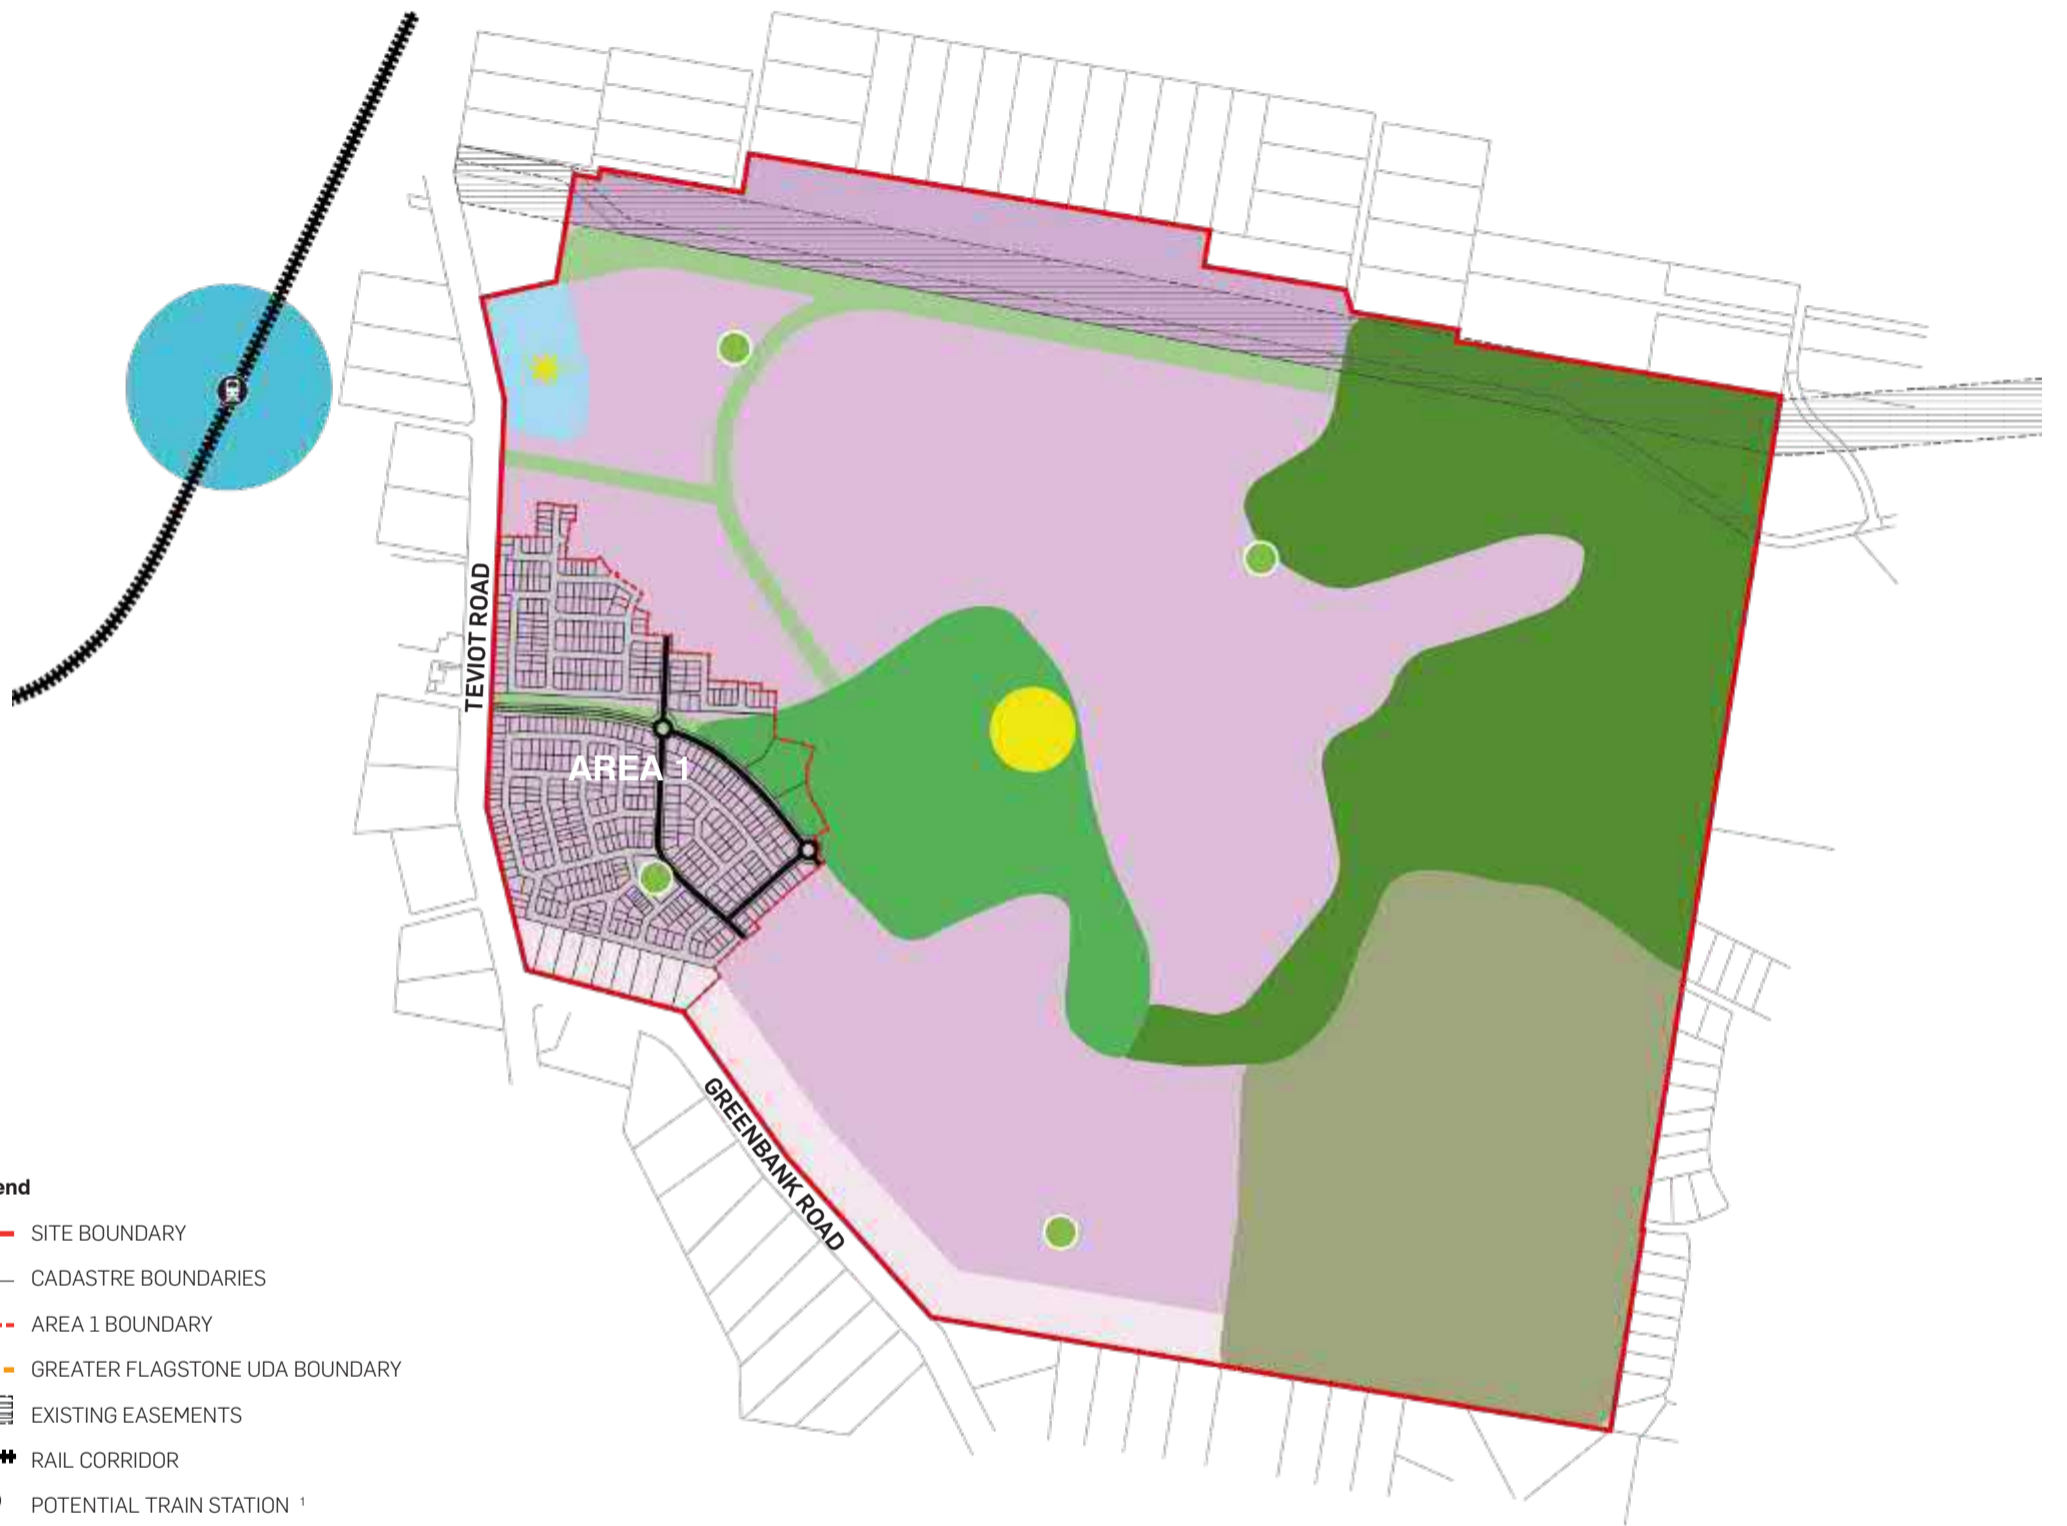
Figure 1 – Overall Land use plan including Area 1

The proposal is to undertake the development of an area identified on the proposal plans as "Area 1". Area 1 is located in the western portion of 138-168 Teviot Road, Greenbank (Lot 434 on RP845844 covering an area of 400.8 hectares) (see Figure 1 of Appendix A).

This Bushfire Hazard Assessment and Fire Management Plan has been prepared for Mirvac Qld with respect to the development application over Area 1 and the immediate vicinity as identified in Figure 1 (see Appendix A). The footprint of Area 1 is located within Mirvac's Greenbank land holding as identified below:

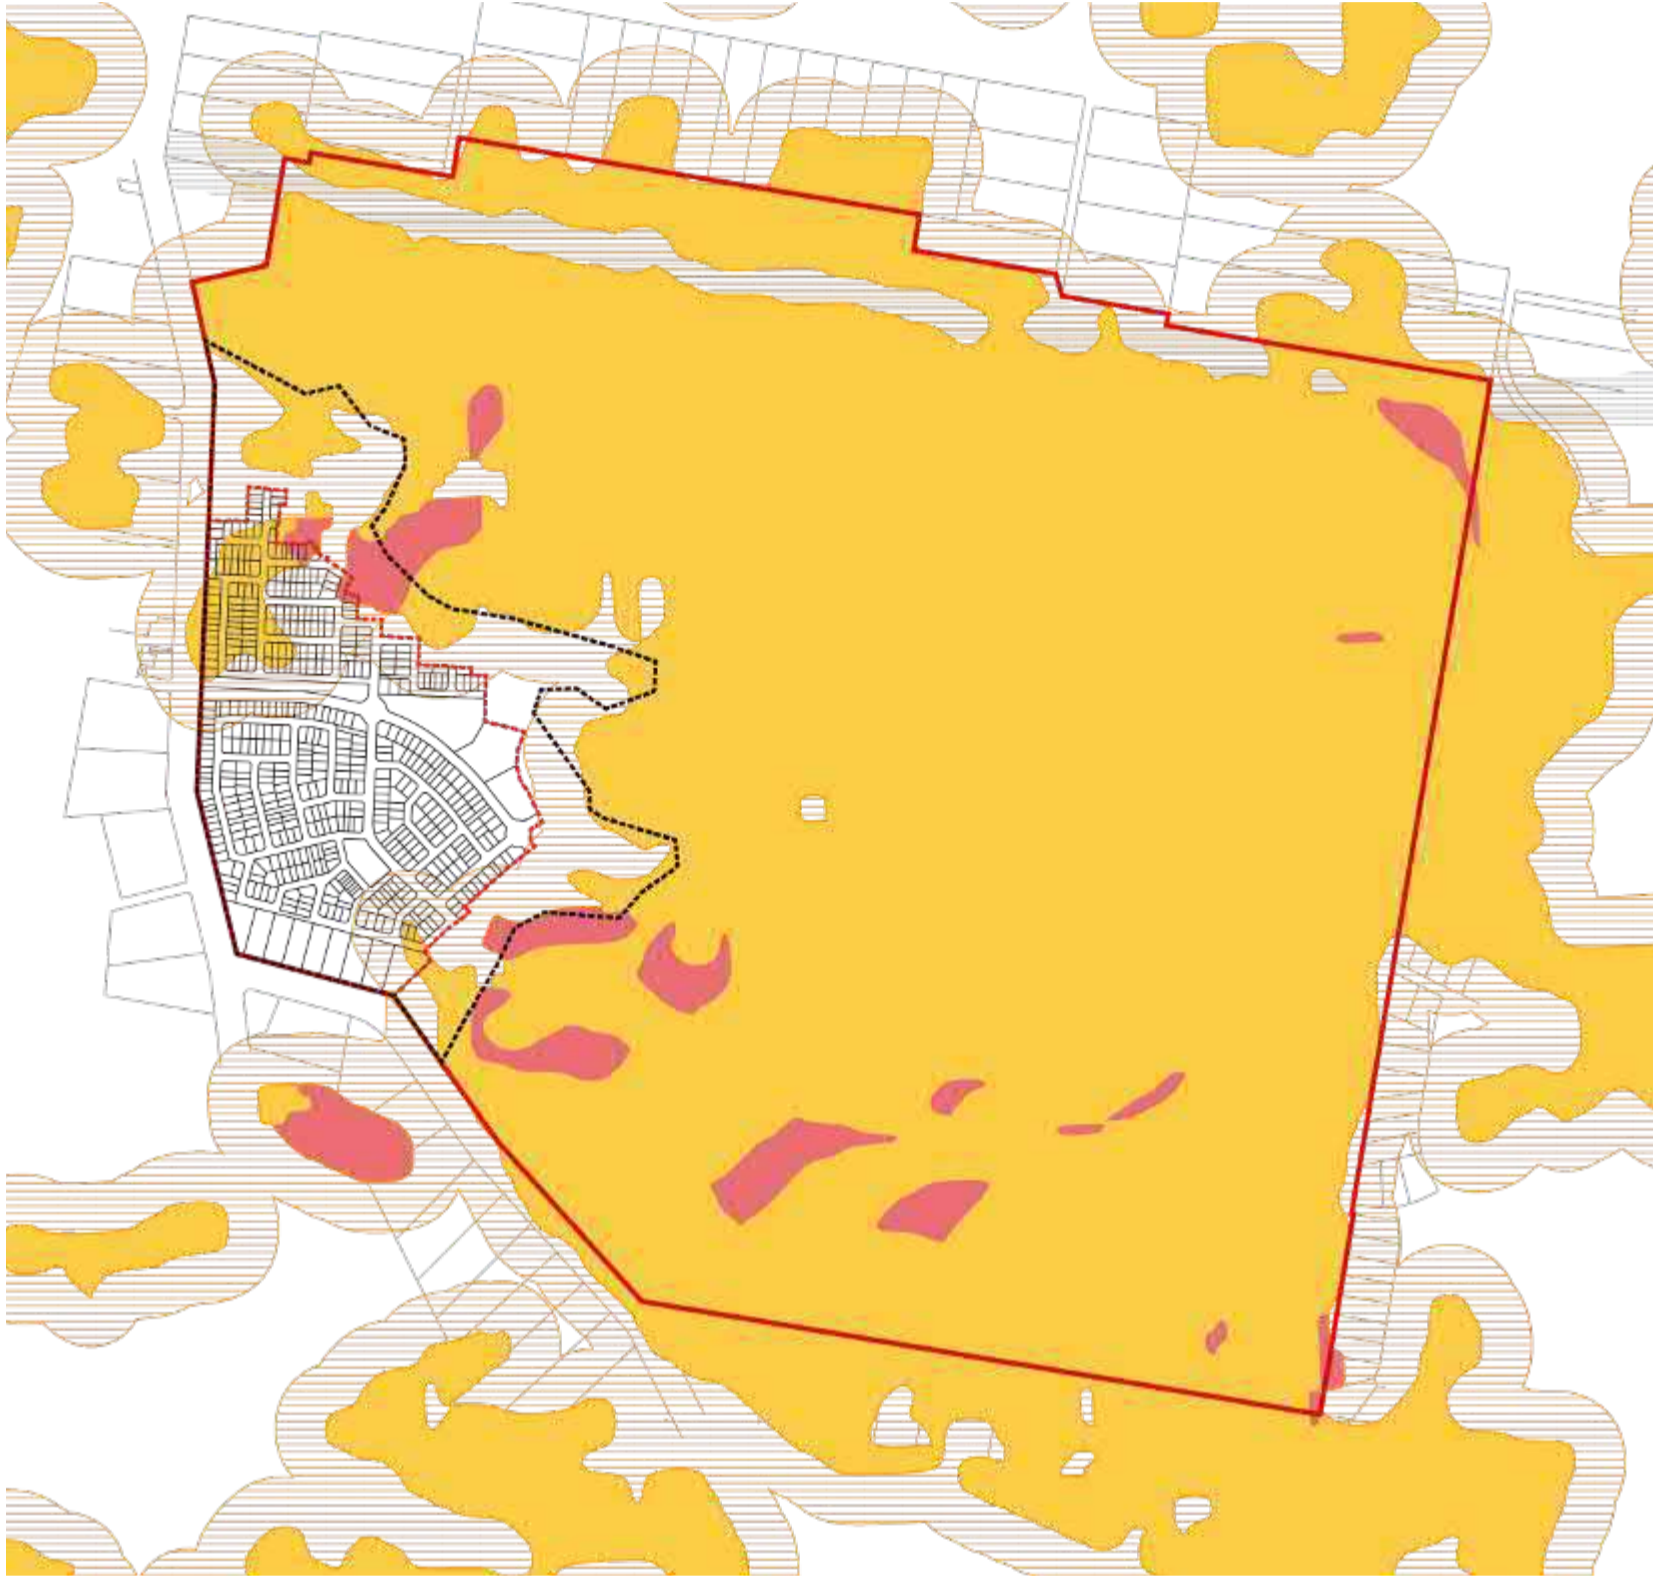
Figure 2 – Bushfire hazard plan – Area 1 – Pre-clearing

The Natural Hazards Risks and Resilience - Bushfire hazard area mapping provided by the State Planning Policy of April 2016, maps areas of High and Medium potential bushfire intensity over some of the area over which Area 1 will be developed (see Figure 2).

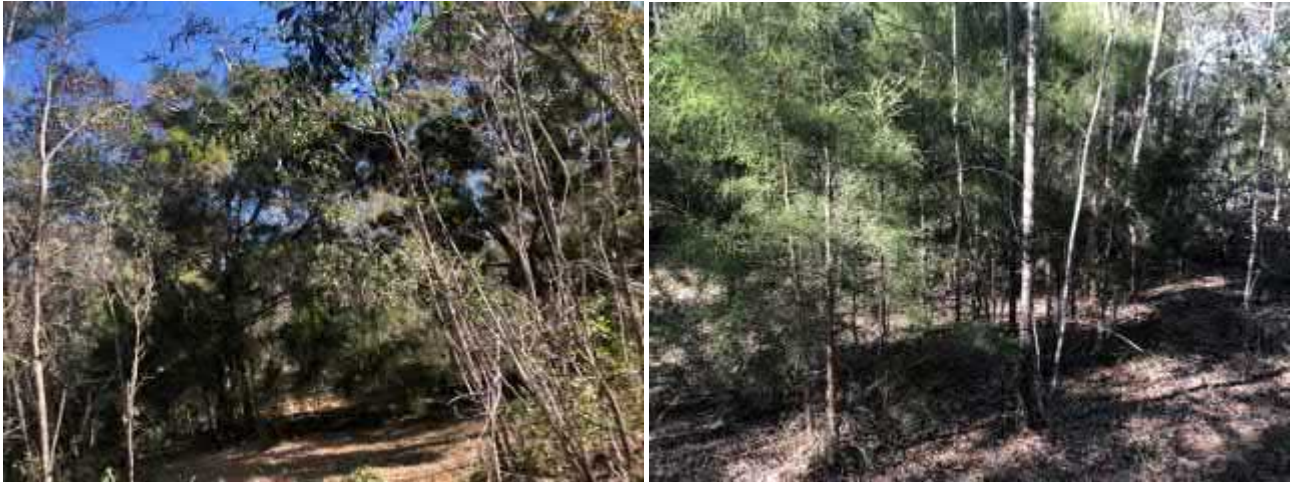
Photo Plate 1: Location 1

Location 1 is situated in the northern aspect of the site, adjacent to the power easement. This patch is located within mapped composite 'Of Concern' Regional Ecosystem RE12.9-10.2/12.9-10.7 as confirmed via PMAV 2016/002969 certified on the 11th of May 2017. This patch of *Melaleuca irbyana* (Swamp Tea-tree) consists of three (3) established specimens, one (1) semi-mature specimen and one-hundred (100) juveniles. This patch of *Melaleuca irbyana* was surrounded by vegetation dominated by *Acacia spp.*, *Allocasuarina littoralis* (Black She-oak) and *Alphitonia excelsa* (Soap Tree) regrowth with *Corymbia citriodora* (Spotted Gum) dominated canopy, representing the Least Concern RE12.9-10.2.

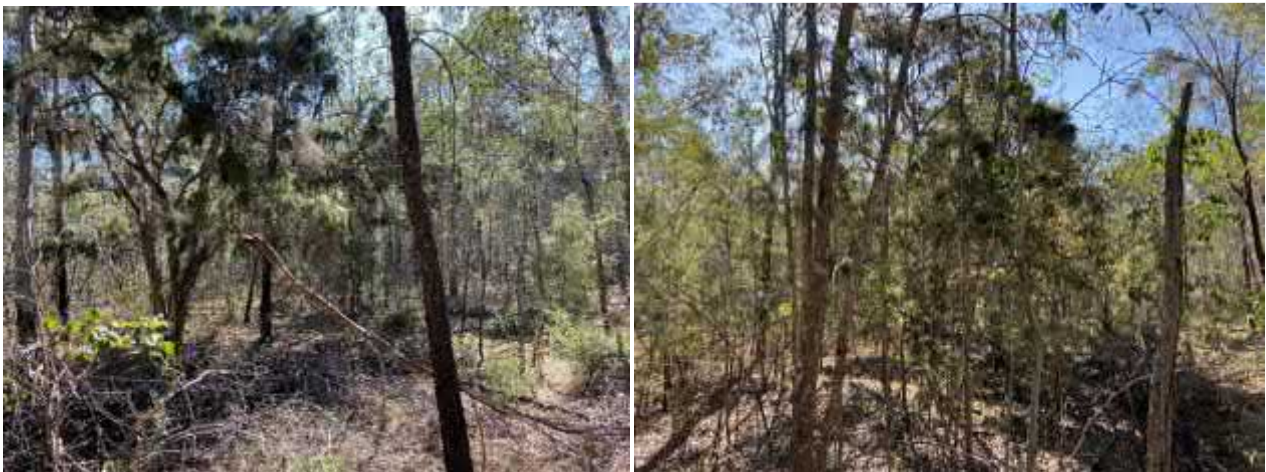
Photo Plate 2: Location 2

Location 2 is situated towards the south-western property boundary, adjacent to Greenbank Road. This patch is located within mapped non-remnant vegetation as confirmed via PMAV 2016/002969 certified on the 11th of May 2017. This *Melaleuca irbyana* (Swamp Tea-tree) patch consists of three (3) established (mature) specimens, eleven (11) semi-mature specimens and ten (10) juvenile specimens. This patch of *Melaleuca irbyana* was found within a regrowth vegetation community, with surrounding vegetation dominated by *Allocasuarina littoralis* (Black She-oak) and *Acacia spp.* regrowth.

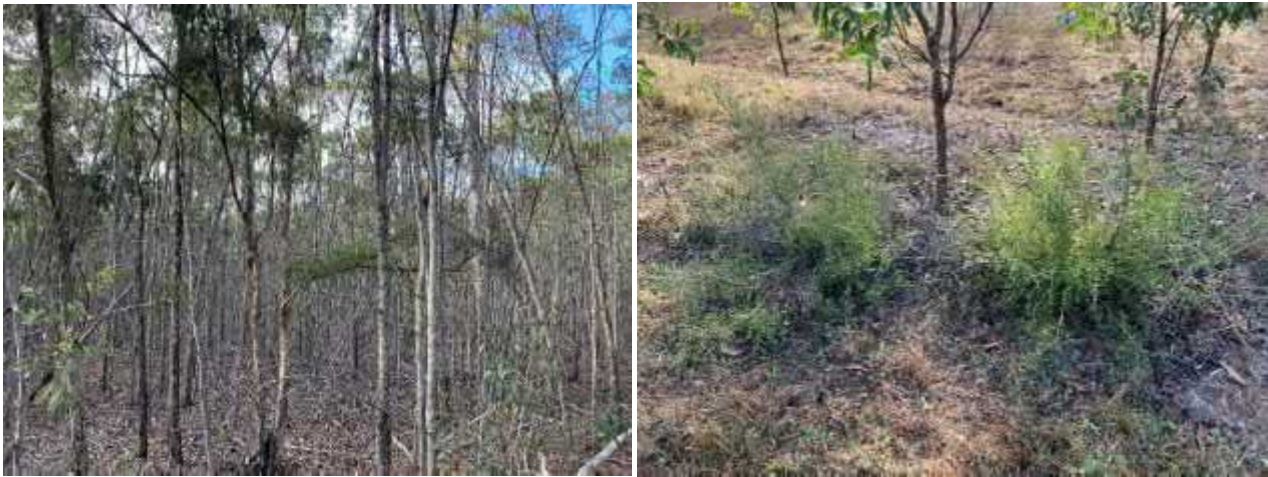
Photo Plate 3: Location 3

Location 3 is situated towards the south-western property boundary, adjacent to Greenbank Road and approximately 380 m west of Location 2. This patch is located within mapped non-remnant vegetation as confirmed via PMAV 2016/002969 certified on the 11th of May 2017. This patch of *Melaleuca irbyana* (Swamp Tea-tree) consists of six (6) mature specimens, eleven (11) semi-mature specimens and fourteen (14) juvenile specimens. The overall patch of *Melaleuca irbyana* was found within a regrowth vegetation community, with surrounding vegetation dominated by *Acacia leiocalyx* (Early Flowering Black Wattle), *Allocasuarina littoralis* (Black She-oak) and *Alphitonia excelsa* (Soap Tree) regrowth. The patch is separated into four separate patches.

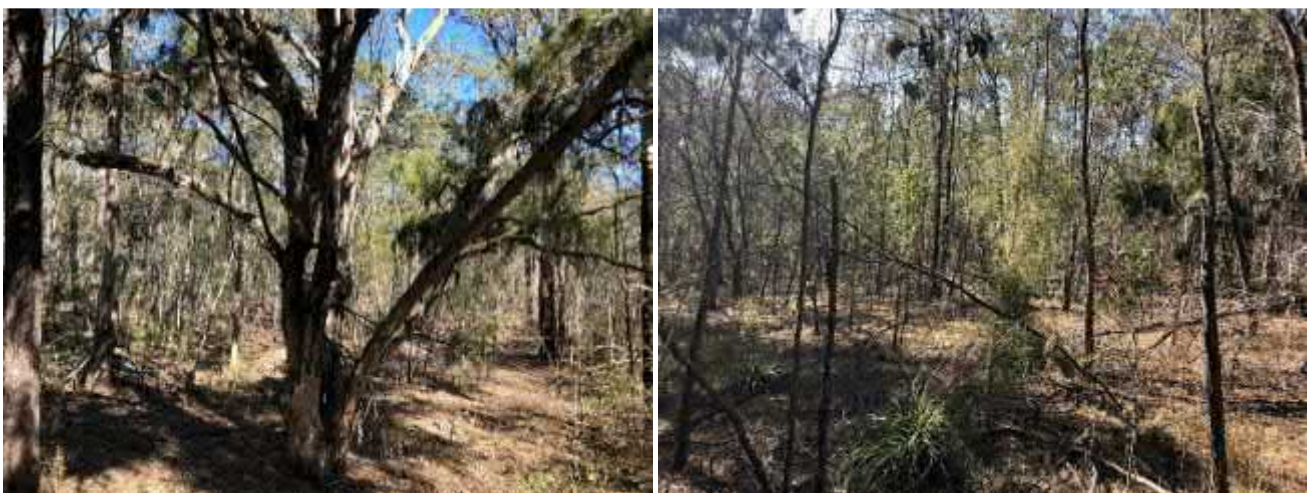
Photo Plate 4: Location 4

Location 4 is situated towards the southern property boundary, approximately 800 m east of Location 3. This patch is located within mapped composite 'Of Concern' Regional Ecosystem RE12.9-10.2/12.9-10.7 as confirmed via PMAV 2016/002969 certified on the 11th of May 2017. This patch consists of five (5) mature specimens, one hundred and seven (107) semi-mature specimens and eight (8) juvenile specimens with a height less than two (2) meters. This patch of *Melaleuca irbyana* was surrounded by vegetation dominated by *Acacia spp.*, *Allocasuarina littoralis* (Black She-oak) and *Alphitonia excelsa* (Soap Tree) regrowth with *Corymbia citriodora* (Spotted Gum) dominated canopy, typically representing the Least Concern RE12.9-10.2.

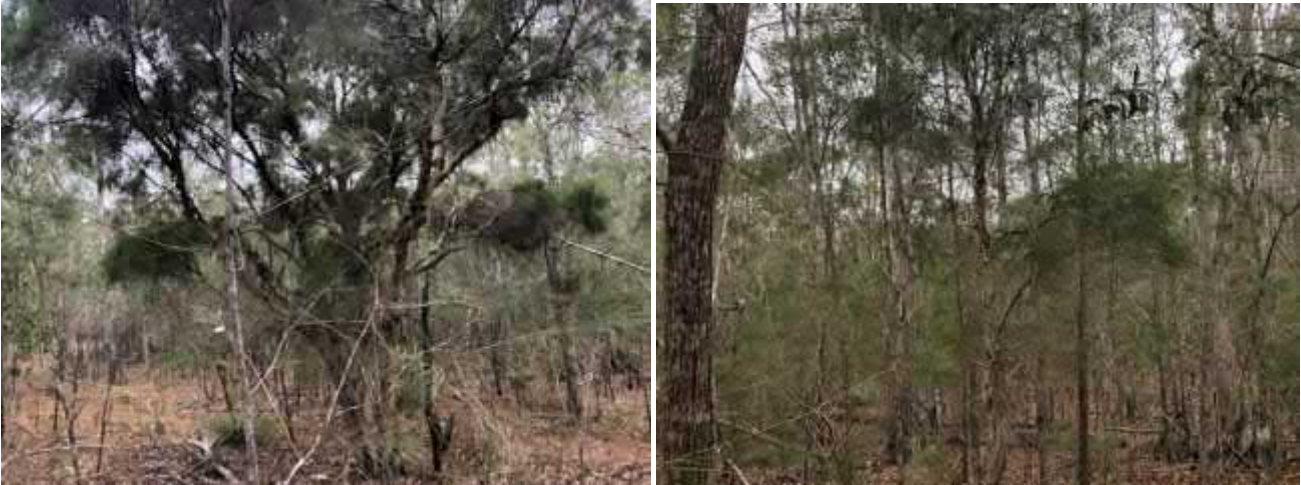
Photo Plate 5: Location 5

Location 5 is situated towards the central portion of the development footprint. This patch is located within mapped non-remnant vegetation or Category X as confirmed via PMAV 2016/002969 certified on the 11th of May 2017. This patch consists of two (2) mature specimens retaining a trunk DBH greater than 100mm, three (3) semi-mature specimens with a trunk less than 100mm and a height greater than two (2) meters, and thirty-four (34) juvenile specimens with a height less than two (2) meters. This patch of *Melaleuca irbyana* was surrounded by vegetation dominated by *Allocasuarina littoralis* (Black She-oak) with scattered *Acacia leiocalyx* (Early Flowering Black Wattle), *Eucalyptus crebra* (Narrow Leaf Ironbark) and *Eucalyptus tereticornis* (Forest Red Gum). These species are typical of the Of Concern Regional Ecosystem community 12.9-10.7.

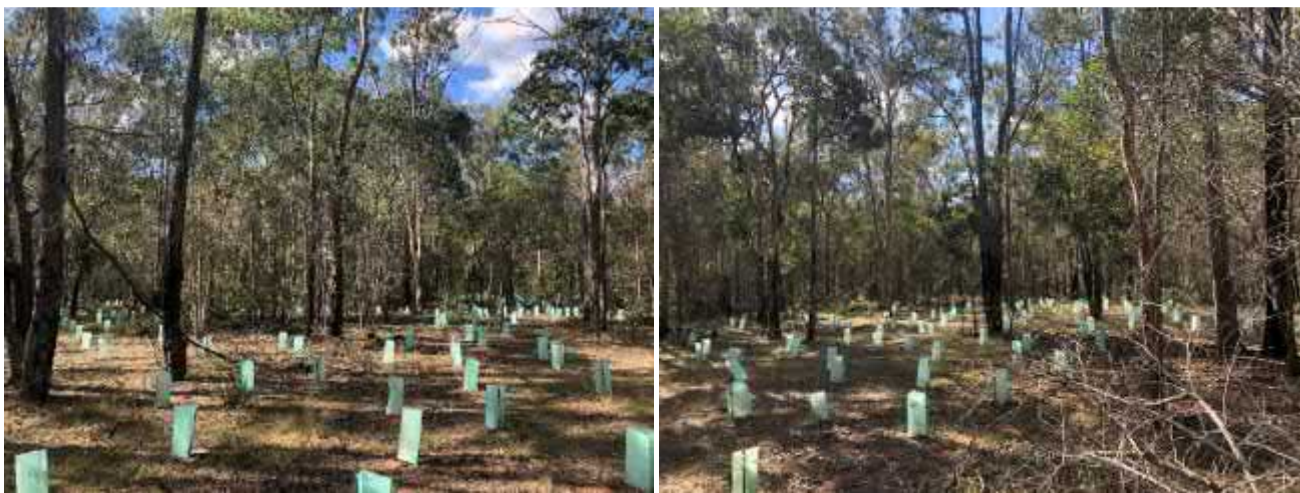
Land care Consultants Evolve were engaged by Mirvac to undertake installation and establishment of the *M. irbyana* rehabilitation area. Rehabilitation works area ongoing in accordance with the Rehabilitation Plan (refer Photos below). It is understood that the *M. irbyana* offset area planting was completed in January 2020 and Evolve are continuing maintenance practices as specified in the approved Rehabilitation Plan. Refer to **Plan 3** for a plan of the rehabilitation area extracted from the VDec.

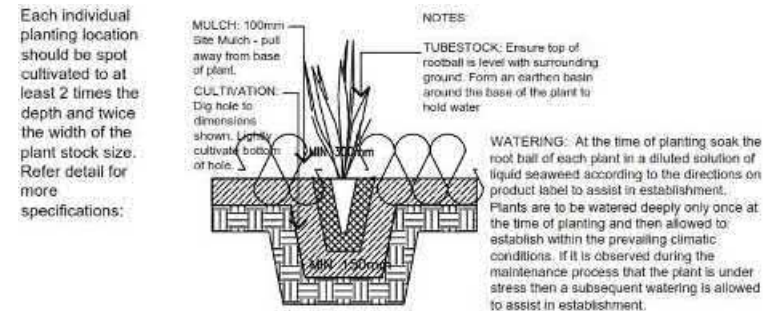
Areas to be blanket mulched to a minimum depth of 100mm leaving a 50mm gap surrounding the trunk of planted stock. Areas which are too steep or where overland flows may occur, a combination of mulch and Jute mat and/or suitably anchored natural fibre weed mat installed to manufactures specifications have been specified.

Typical planting details as below for standard medium mulch installation and jute netting. Refer to manufacturer's recommendations for detailed jute netting installation including pinning, etc.

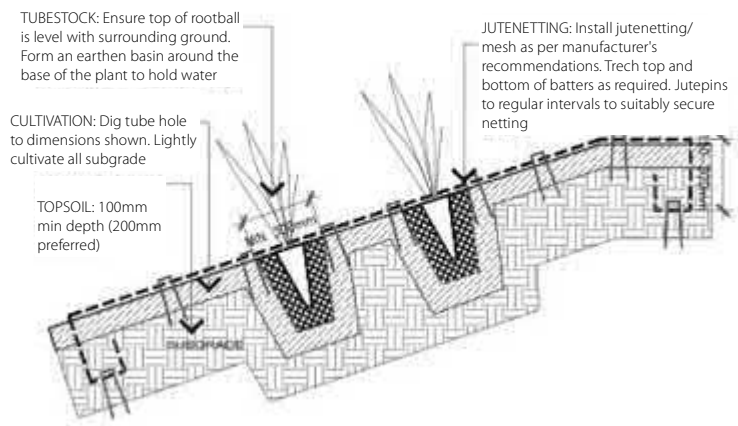
Where evidence of plant damage is occurring i.e. Kangaroo or wallaby grazing, tree guards grow tubes to be installed as required.

Jute netting mesh to be installed as per manufacturer's recommendations. Indicative detail shown only.

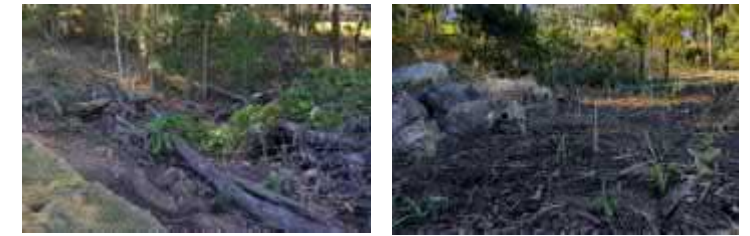
Rehabilitation Areas to include reuse of site fallen hollow logs and site rock to create fauna safe havens and cover from predators for small fauna. This approach coupled with additional revegetation works allows greater fauna security and movement within the rehabilitation areas. Consideration for bushfire requirements should be reviewed to confirm no conflict in both the fauna and rehabilitation approaches. Refer indicative images below.

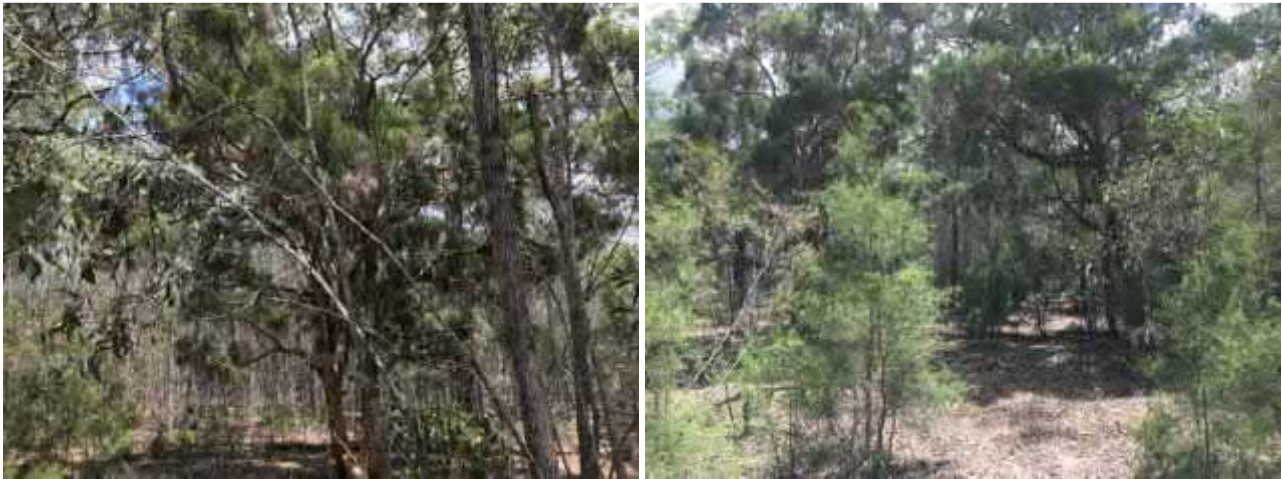
Photo Plate 1: Location 1

Location 1 is situated in the northern aspect of the site, adjacent to the power easement. This patch is located within mapped composite 'Of Concern' Regional Ecosystem RE12.9-10.2/12.9-10.7 as confirmed via PMAV 2016/002969 certified on the 11th of May 2017. Refer to Plan 1 for *Melaleuca irbyana* on site locations and Table 3 for a description of the Regional Ecosystems). This patch of *Melaleuca irbyana* (Swamp Tea-tree) consisted of three (3) established specimens and one-hundred (100) juveniles. This patch of *Melaleuca irbyana* was surrounded by vegetation dominated by *Acacia spp.*, *Allocasuarina littoralis* (Black She-oak) and *Alphitonia excelsa* (Soap Tree) regrowth with *Corymbia citriodora* (Spotted Gum) dominated canopy.

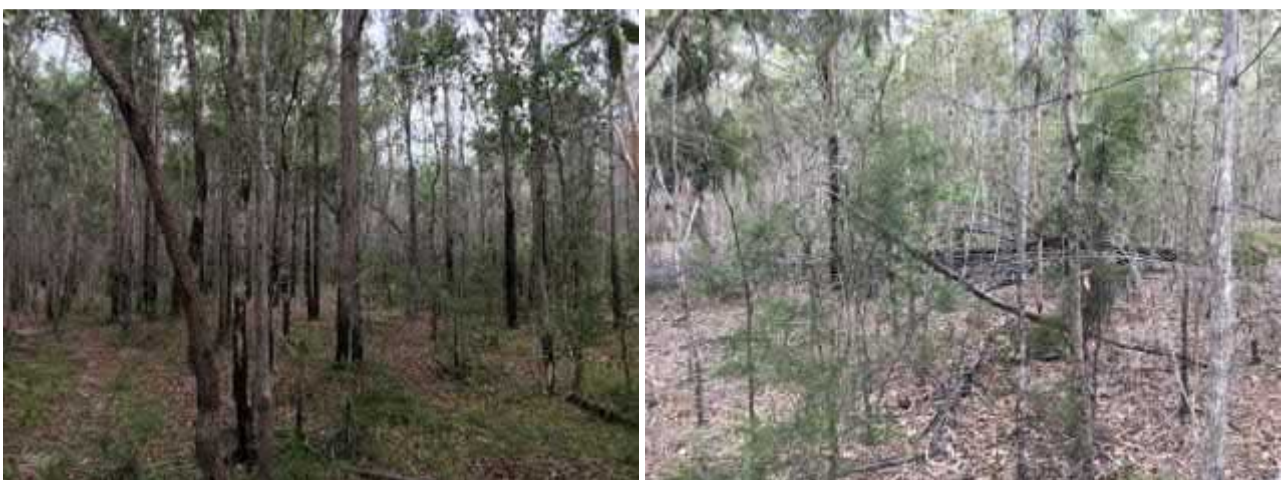
Photo Plate 2: Location 2

Location 2 is situated towards the south-western property boundary, adjacent to Greenbank Road. This patch is located within mapped non-remnant vegetation as confirmed via PMAV 2016/002969 certified on the 11th of May 2017. This *Melaleuca irbyana* (Swamp Tea-tree) patch consisted of three (3) established specimens and twenty (20) juveniles. This patch of *Melaleuca irbyana* was found within a regrowth vegetation community, with surrounding vegetation dominated by *Allocasuarina littoralis* (Black She-oak) and *Acacia spp.* regrowth.

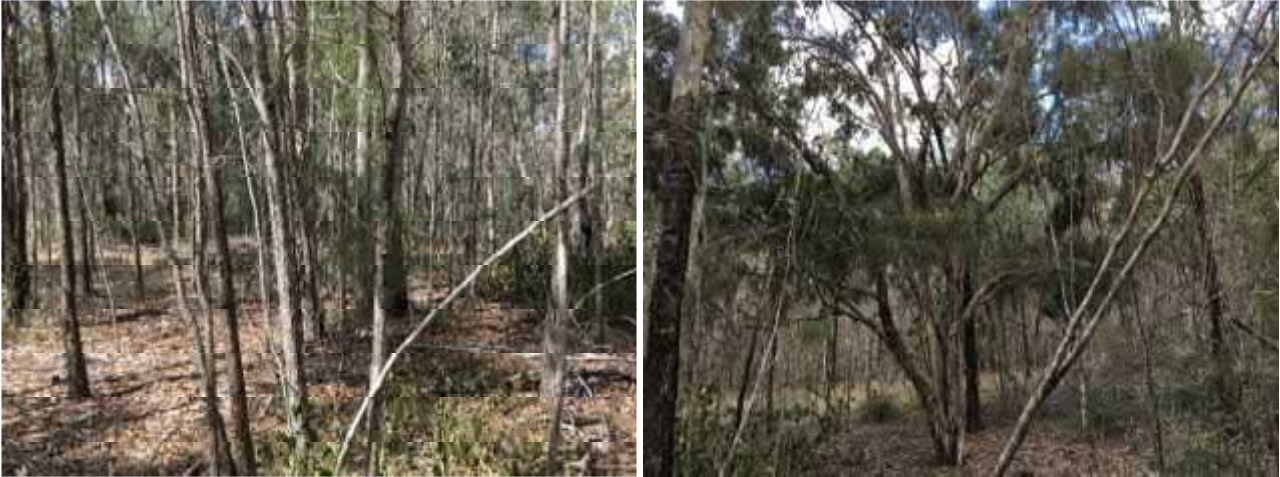
Photo Plate 3: Location 3

Location 3 is situated towards the south-western property boundary, adjacent to Greenbank Road and approximately 380 m west of Location 2. This patch is located within mapped non-remnant vegetation as confirmed via PMAV 2016/002969 certified on the 11th of May 2017. This patch of *Melaleuca irbyana* (Swamp Tea-tree) consisted of four (4) established specimens and ten (10) juveniles. The patch of *Melaleuca irbyana* was found within a regrowth vegetation community, with surrounding vegetation dominated by *Acacia spp.*, *Allocasuarina littoralis* (Black She-oak) and *Alphitonia excelsa* (Soap Tree) regrowth.

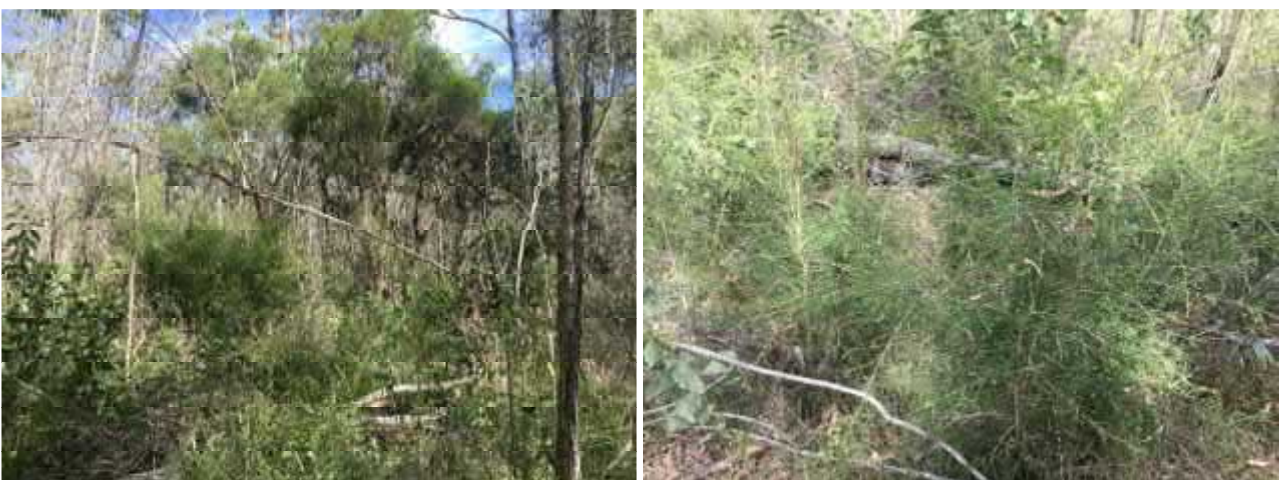
Photo Plate 4: Location 4

Location 4 is situated towards the southern property boundary, approximately 800 m east of Location 2. This patch is located within mapped composite 'Of Concern' Regional Ecosystem RE12.9-10.2/12.9-10.7 as confirmed via PMAV 2016/002969 certified on the 11th of May 2017. These Regional Ecosystems are described in Table 3 below. This patch consists of five (5) established specimens and one hundred and ninety-eight (198) juveniles. This patch of *Melaleuca irbyana* was surrounded by vegetation dominated by *Acacia spp.*, *Allocasuarina littoralis* (Black She-oak) and *Alphitonia excelsa* (Soap Tree) regrowth with *Corymbia citriodora* (Spotted Gum) dominated canopy.

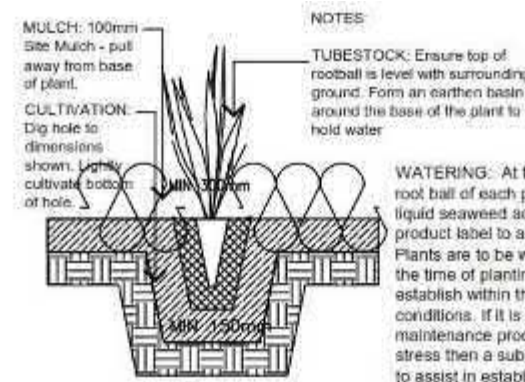
Each individual planting location should be spot cultivated to at least 2 times the depth and twice the width of the plant stock size. Refer detail for more specifications:

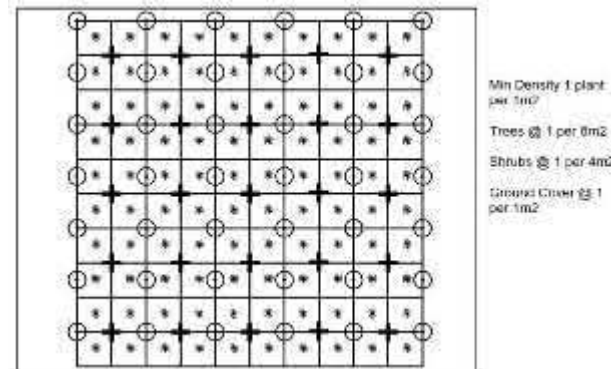
PLANTING

Planting locations shall be generally set out in accordance with a typical random grid pattern as shown on this drawing sheet below with the *Melaleuca Irbyana* to be planted at 1 per 8m².
